Mining and Environment in Vietnam
Stabilization of Waste Rock Dumps from Coal Mining in Vietnam

Research Association
Mining and Environment
in Vietnam

Problem definition and objectives

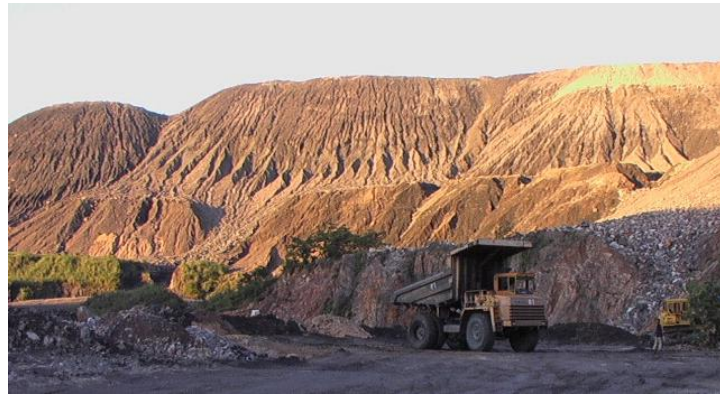
Figure 1: Erosion on waste rock dump slopes

The design of waste rock dumps is currently carried out on the base of experience only, usual stability analysis are not applied. The dumps are being built as sidehill-fill by simply dumping material over the crest without any further compaction. This construction method results in massively emerging subsidence that is leading to severe damage to the slopes, because developing cracks are creating initial points

for internal erosion processes. In the recent past repeatedly larger slope areas failed due to this processes and caused major damage.

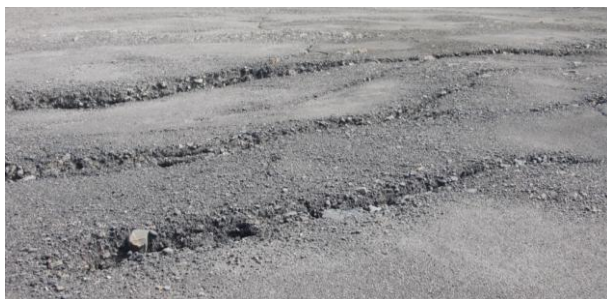
Figure 2: Cracks on the dump surface

These models help to identify areas, where the stability could possibly be endangered. All over the surface of the dump, effects of large subsidence are visible, as there are wide open cracks, signs of large differential settlements and obvious changes of the surface inclination. An annual mapping of the cracks, active areas of the dump were identified and enabled to draw conclusions on the causes for the slope movements. First analyses show that the stability of the slopes is more significantly affected by erosion processes than by geotechnical slope stability failures.

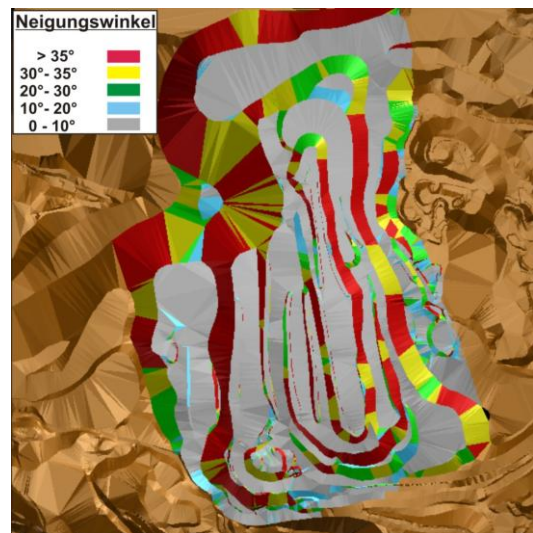
Figure 3: 3D-model of the dump

Based on AutoCAD-plans provided by the vietnamese project partners, three-dimensional models of the dump were created with the mine-planning software SURPAC.

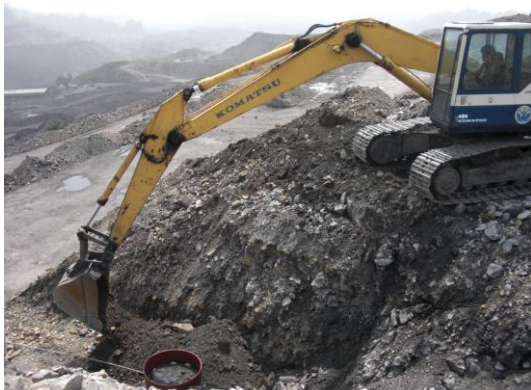
Figure 4: Trial pit for field testing

For the definition of geotechnical parameters, samples were taken for laboratory testing and field testing has been carried out on-site in several trial pits. Most of the laboratory tests were carried out by a local laboratory for soil mechanics, but it was quite difficult to find equipment for the dumped material, as the maximum particle size exceeds the limitations of standard laboratory equipment. Thus a new device will be built by the german partners for the definition of shear strength parameters.

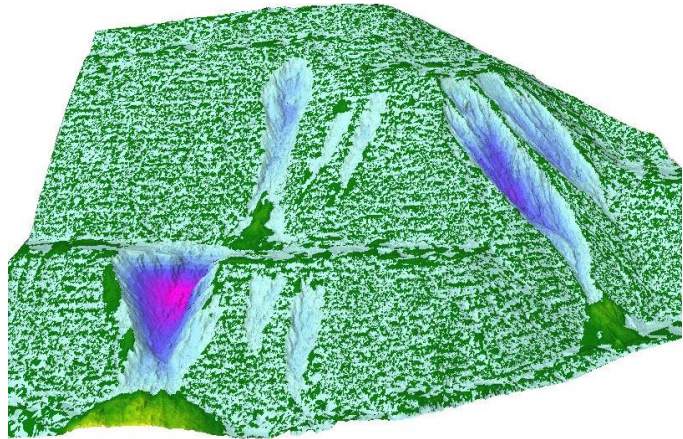
Figure 5: 3D-record of erosion

To gather information about the existing damages caused by erosion of the slopes of new as well as older parts of the dump, an ILRIS 3D-terrestrial laserscanner is used. The scanning records are used to build a refined digital model. By comparing the records from different moments, the volume change can be quantified by calculating the differential changes between the records.

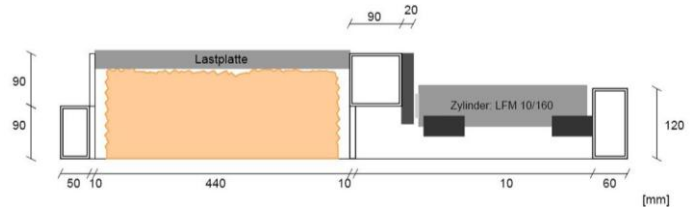
Figure 6: sketch of the mobile shear testing device

As already mentioned above, no adequate laboratory equipment for the definition of shear parameters for the particle sizes of the waste rock material was found in the region, the Institute of Geotechnical Engineering is developing a mobile shear testing device to carry out tests on-site. The device will firstly be calibrated under laboratory conditions and used in Vietnam after preliminary field tests in Germany.
